Hydrogen in Gas Grids

A systematic validation approach at various admixture levels into high-pressure grids

D4.3

Update on test results

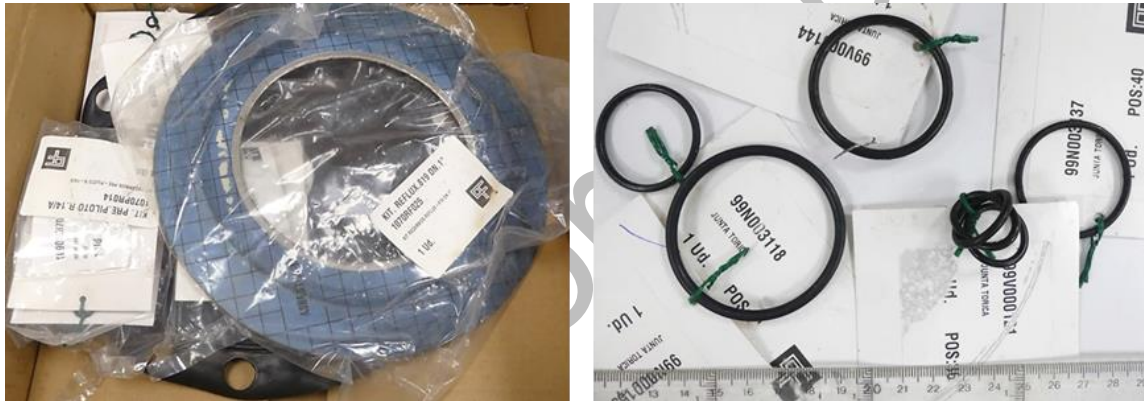
The pilot-operated pressure regulator and cartridge filter tested in the dynamic section of the testing platform, were disassembled at the end of the test and their different parts examined with the aid of a stereo microscope with a camera, to detect cracking or other type of hydrogen damage such as blistering. Apart to linear or scratch abrasion in certain components, mainly generated in the process of disassembling, no clear signs of hydrogen damage were observed on the different parts inspected. Figure 2 to Figure 7 show the general appearance and some more detailed analysis of some of the examined items. No blistering was observed in the plastic or polymeric components at the time of removal from the testing platform. No cracking was detected for any of the metal components.

Figure 2. Parts of the pressure regulator (left) and detail of some of the pilot O-rings inspected (right)

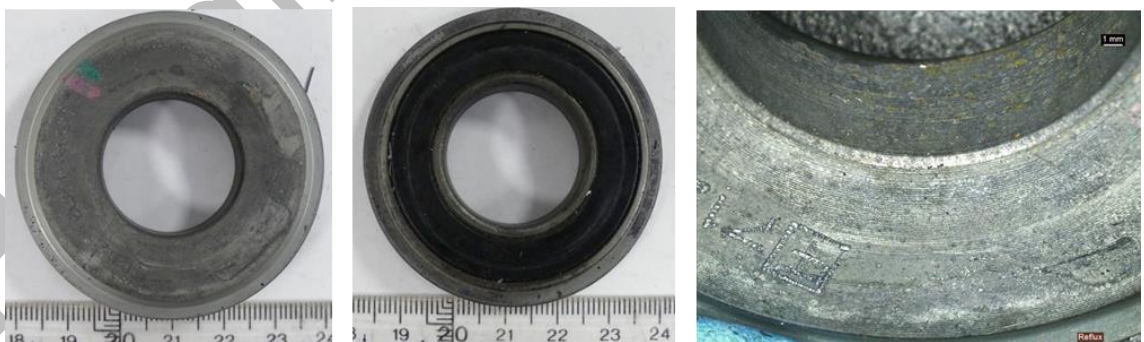
Figure 3: Detail of the gasket from the pressure regulator

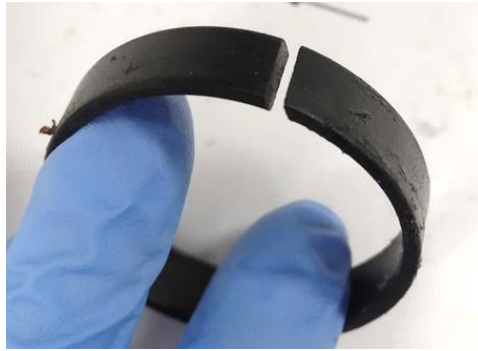
Figure 4. Pilot guide ring from the pressure regulator

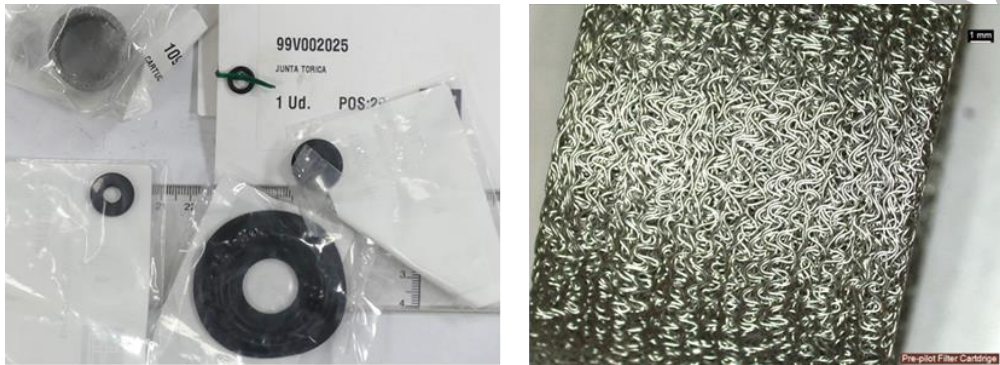
Figure 5. Pre-pilot pressure regulator components (left) and detail of filter cartridge (right)

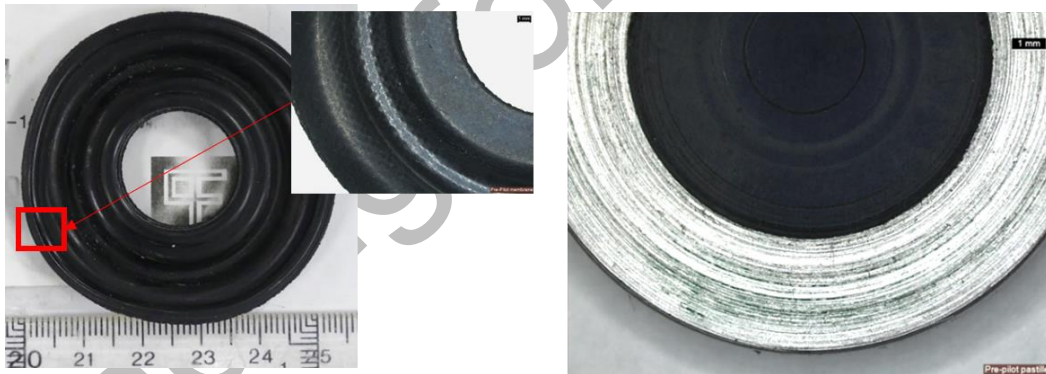
Figure 6. Pre-pilot membrane (left) and pad (right)

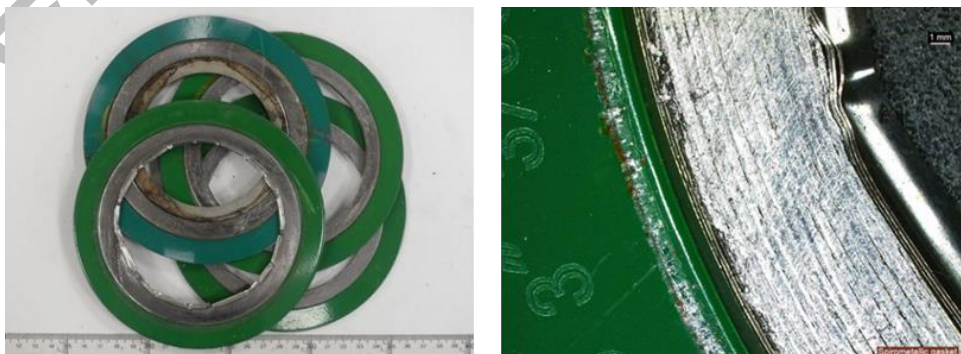
Figure 7. Spirometallic gaskets

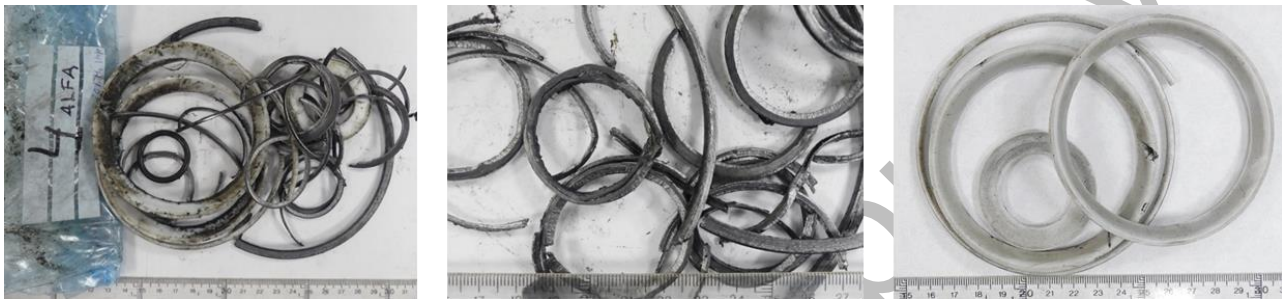
The main body of the plug, the ball and the butterfly valves installed in the static section of the R&D platform (see Table 1), were disassembled at the end of the 2nd experimental campaign and inspected to detect signs of hydrogen damage. In general, the Teflon seals did not show any significant damage, except for that which may have been generated in the process of disassembling of the valve. The seal bodies made of Graphoil were in many cases broken or fragmented, most probably due to the process of dismantling of the valve, as it is a very soft and flexible material. Figure 8 and Figure 9 show the general appearance of some of the examined items.

Figure 8. Components of the ALFA VALVOLE ball valve (n° 4) (left) showing detail of the graphoil (centre) and Teflon seals (right)

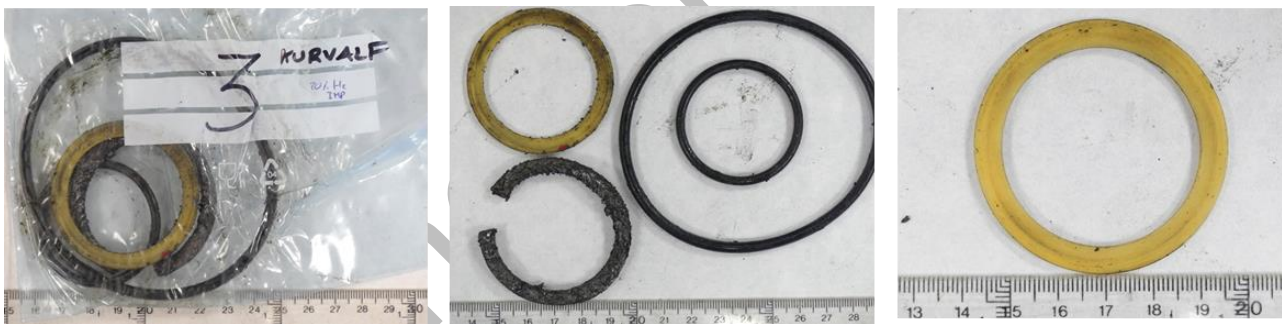
Figure 9. Components of the KURVALF plug valve (left) showing detail of the O-rings (middle) and the graphoil and Teflon seals (right)

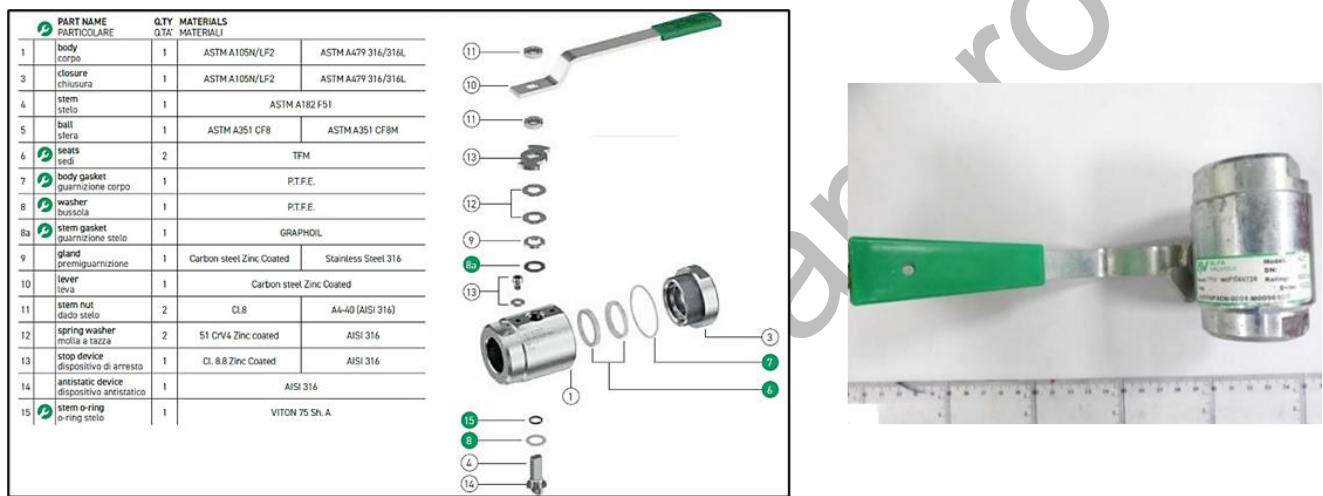
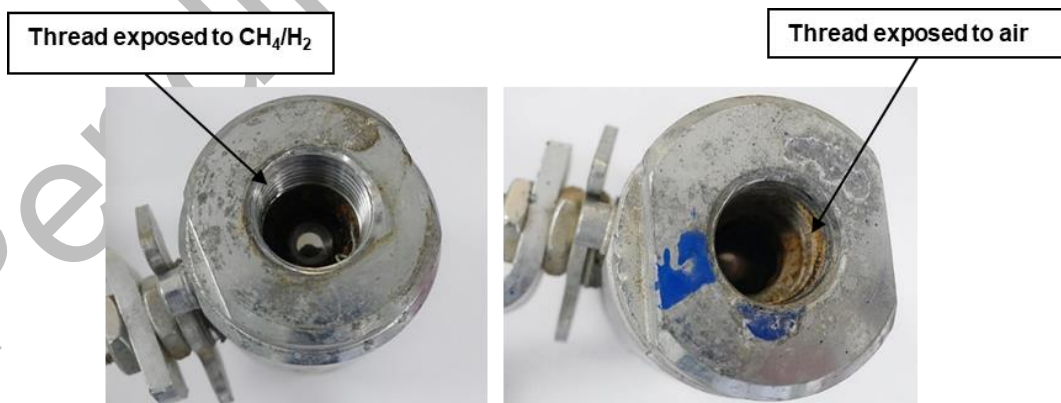
As already reported in D4.2, a gas leakage was detected in one of the testing ball valves at the end of the 2nd campaign. This failure occurred after emptying the platform and filling it again at 4 bar with nitrogen. The valve was sent to Tecnia to evaluate the type of damage observed in the valve.

Figure 10 and Figure 11 show details of this screwed ball valve. The visual inspection of the valve prior to its disassembly revealed a quite significant corrosion in the thread exposed to the air (atmosphere), while the thread in contact to the H₂/CH₄ blend was not corroded, which is logical since the H₂/CH₄ gas mixture is not corrosive.

Figure 10. Photograph showing detail of the ball valve sent to TECNALIA (right) and data sheet supplied by the manufacturer (left)

Figure 11. Photographs showing details of the ball valve

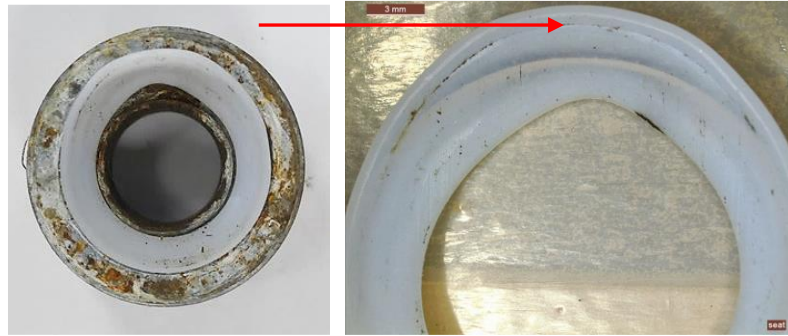
The valve was cut to unscrew the body and closure (probably blocked due to corrosion). A marked not uniform deformation was observed in the Teflon seat located near the closure (see Figure 12), being this fact the most likely cause of the leakage observed in the ball valve. It seems that the ball could not be fully aligned with the seat, so the seat was pushed when the valve was closed and deformed by the ball when opened.

Figure 12. Photographs showing detail of the deformed TFM seat

With regard to the ball valve which presented the gas leakage at the end of the 2nd campaign, the dismantling of the valve showed a non-uniform deformation in the Teflon seat located near the closure, probably due to a misalignment between the ball and the seat. Therefore, the failure could not be attributed to a hydrogen damage.

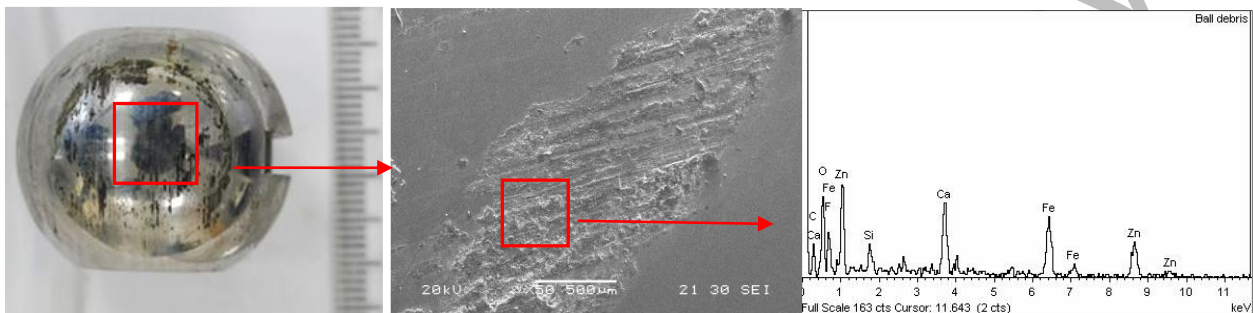
A very little abrasive effect was observed in the stainless-steel ball, mainly attributed to the generation of corrosion products from the carbon steel zinc coated body/closure (see Figure 13). Corrosion products inside the body of the valve were chemically characterized by energy dispersive x-ray spectroscopy (EDS), using a microanalyzer coupled to the SEM (scanning electron microscope). EDS spectra indicated that corrosion products were mainly constituted of zinc (Zn), iron (Fe) and oxygen (O) as zinc and iron oxides (see Figure 14).

Figure 13. Photograph showing detail of the ball (left) and SEM micrograph of abraded area (centre) with EDS spectrum of this zone (right)

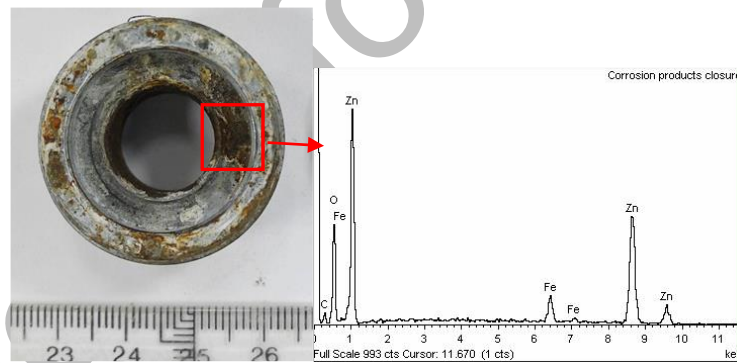
Figure 14. EDS spectrum of corrosion products in valve closure zone

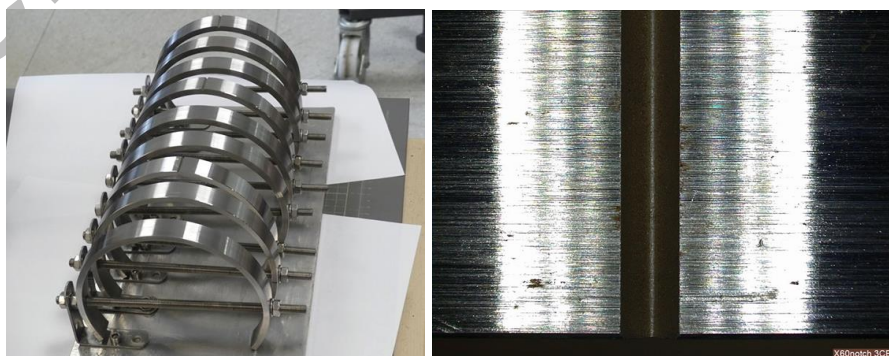
Figure 16 shows the appearance of the tested C-ring specimens after the 3rd experimental campaign. No cracks were detected after optical inspection with a LEICA S9i stereo microscope. Metallographic sectioning confirmed the absence of cracks both in base and C-ring notch samples tested in the 2nd and 3rd campaign, as shown in the optical micrographs in Figure 17, corresponding to specimens tested in the 2nd campaign. Table 7 summarizes the results obtained for the C-ring specimens in the three experimental campaigns carried out until now in the experimental platform.

Figure 16. Detail of tested C-ring specimens (3rd campaign)

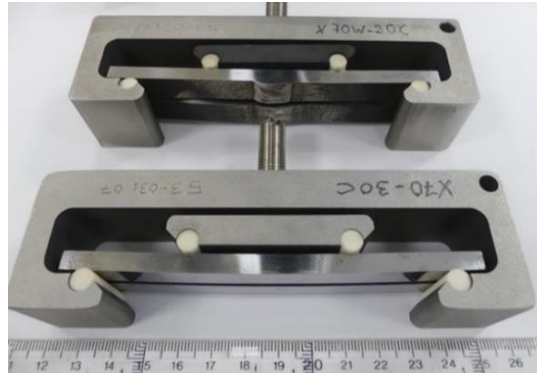
Figure 18 shows the appearance of welded X70 steel 4pb specimens supported in the loading jig, tested during the 3rd experimental campaign. No cracks were detected during the inspection with a stereo microscope. Metallographic sectioning confirmed the absence of cracks in the base, heat affected zone (HAZ) and weld metal areas both for the specimens tested in the 2nd campaign and for those tested in the 3rd campaign, Figure 20 and Figure 21. Table 8 summarizes the results obtained for the 4pb specimens in the three experimental campaigns carried out till now.

Figure 18. Tested X70 base and welded 4pb specimens supported in the loading jig (3rd campaign)

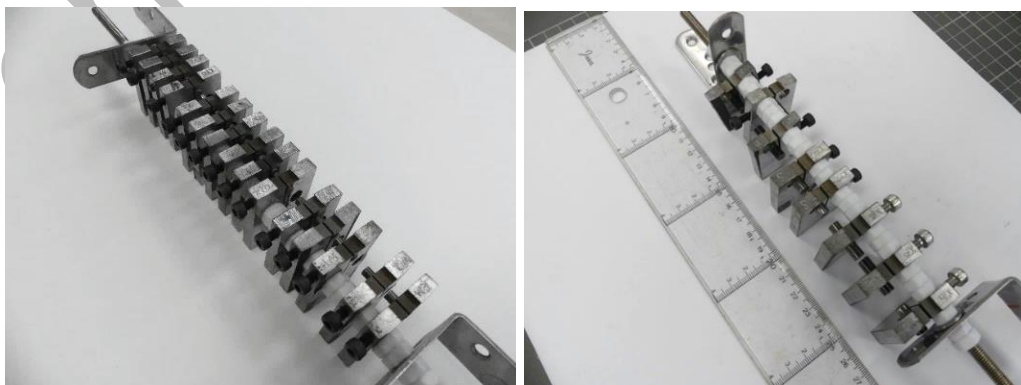
Figure 21 shows the appearance of the racks with the CT-WOL specimens tested in the 2nd and 3rd campaigns. The CT specimens were unloaded (removing the bolt) and then heat tinted (30 min at 300 °C) and broken. The fracture surface was examined by SEM to assess if subcritical cracking occurred from the initial fatigue pre-crack. Measurements of the crack front extent were carried out in three positions and the average crack growth in hydrogen was calculated according to ASTM E1681 standard. No hydrogen crack growth was measured for any CT specimen (crack propagation < 0.25 mm). Fracture surface examination revealed the same fracture mode in the fatigue pre-crack and in the crack front (see Figure 222 and Figure 23). The results for these specimens are summarized in Table 9.

Figure 21. Rack with tested CT bolt loaded specimens in the 2nd campaign (left) and in the 3rd campaign (right)

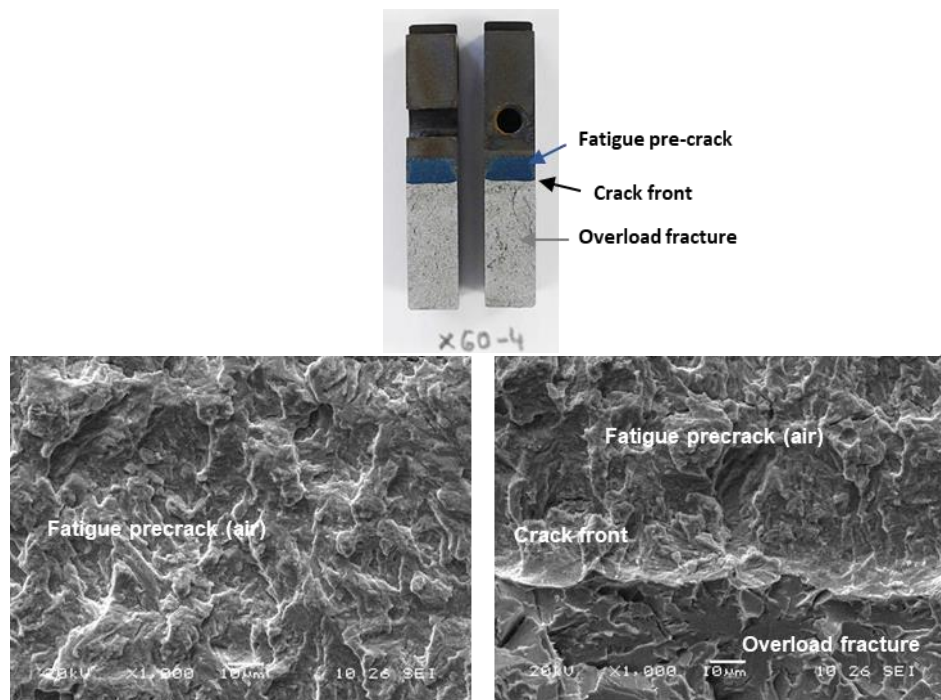
Figure 22. Heat tinted fracture surface of CT-WOL X60 specimen (up) and SEM micrographs of the fatigue pre-crack surface (down-left) and detail of the crack advancing front (down-right)

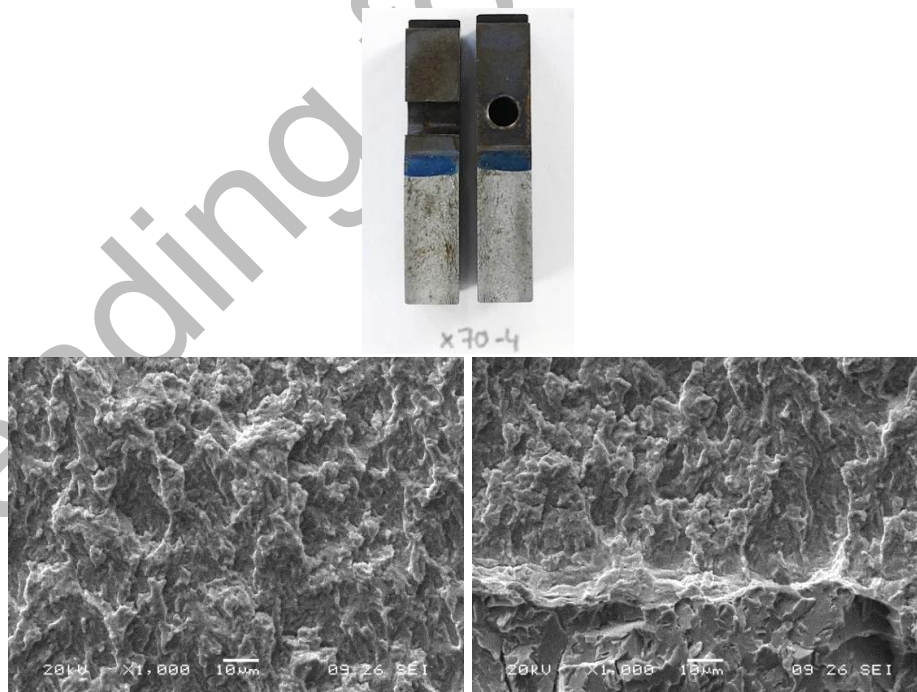
Figure 23. Heat tinted fracture surface of tested CT-WOL X70 specimen (up) and SEM micrographs of the fracture surface in the fatigue pre-crack and in the crack front (down)

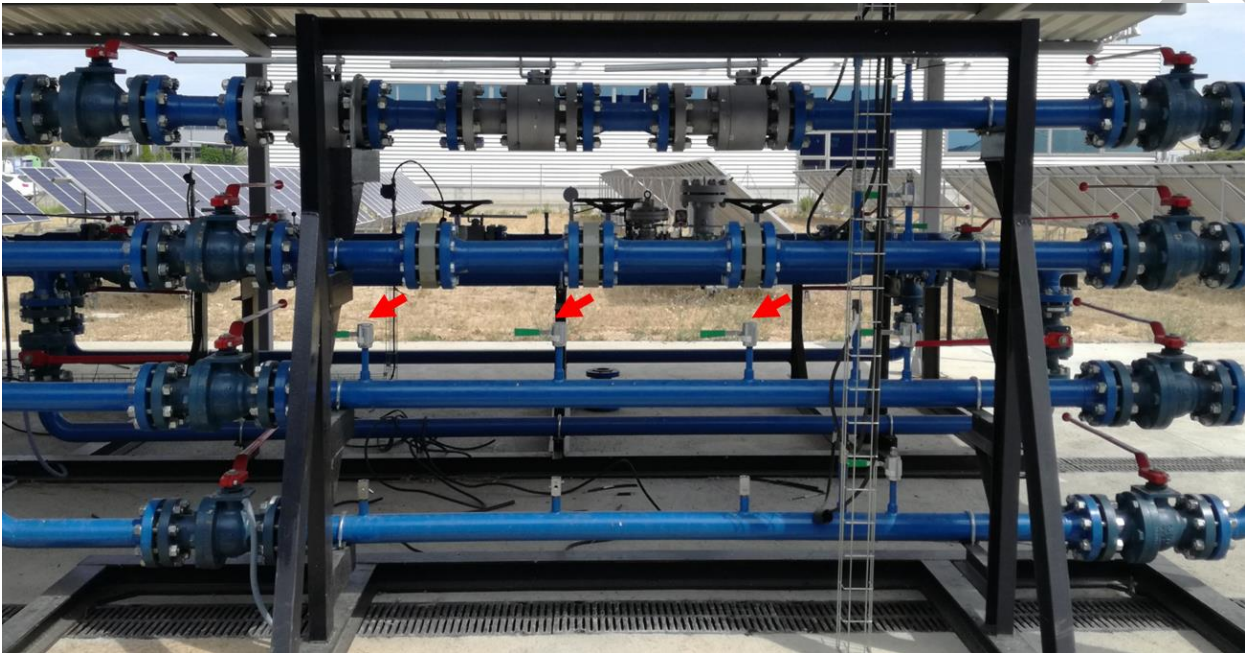
So far, most valves and couplings remain tight. There is, however, a critical leakage in the line containing screwed ball valves, where the pressure has dropped almost 30 bar during this first stage of the test. This leakage is due to a lack of internal sealing capacity in this component, since constant hydrogen concentrations up to 1mol% can be detected with a gas detector at the point depicted in Figure 25. This fact occurred for all the three testing valves, so this specific kind of valves may not be suitable for hydrogen service at such levels of blend. Regarding the hydrogen concentration in the lines, it is surprising how the hydrogen level seems to increase as the test advances. This fact may be indicative of hydrogen stratification in the line since the points where the samples are taken are located at the top of the pipes. More data are, however, necessary to reach a conclusion.

Figure 25. Picture of part of the static section of the testing platform. Red arrows show the point where hydrogen leakages were detected
