# Hydrogen in Gas Grids

**A systematic validation approach at various admixture levels into high-pressure grids**

## D4.2 Report on results of the validation

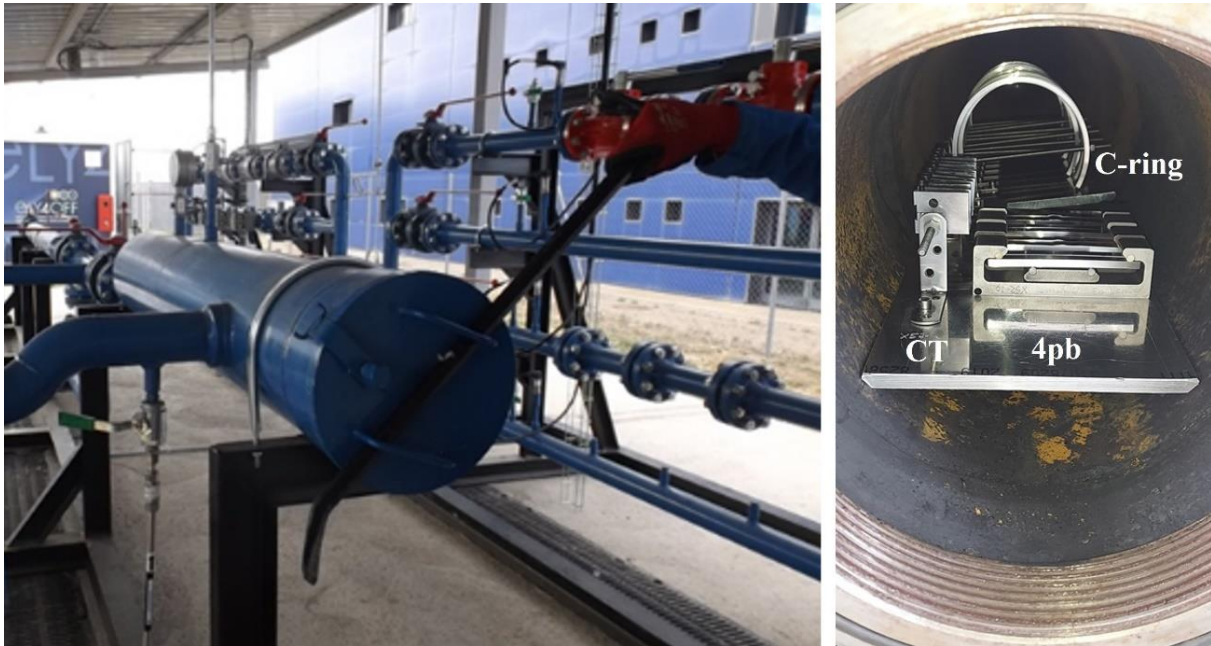
**Figure 3. Picture of the pig trap (left) and the constant strain specimens allocated inside it (right)**

benefit of using constant strain specimens is that once the deformation has been applied to the specimen, the self-loading assemblies may be inserted into loops or closed test vessels and exposed to the hydrogen environment at a certain pressure. For this reason, a pig trap was installed in the dynamic section of the testing platform, aiming as an autoclave that can operate at 80 bar and in which the specimens have been allocated for the test. Three types of normalized constant displacement specimens have been developed in this work: C-ring, four-point bend (4pb) and compact tension (CT) wedge opening load (WOL) specimens. These specimens have been exposed to the 20%mol H<sub>2</sub> blend at 80 bar for 3000h inside the pig trap (Figure 3)

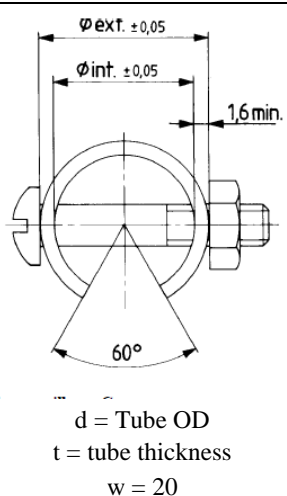
<p> <math>\phi_{ext.} \pm 0,05</math>  <math>\phi_{int.} \pm 0,05</math>            1,6 min.            60°  <math>d = \text{Tube OD}</math>  <math>t = \text{tube thickness}</math>  <math>w = 20</math> </p>

C-rings specimens are made from tubular products and are bolt loaded to the desired stress level, usually comprised between 75 and 100% of the yield strength. Due to the circumferential welding of the pipe sections, C-ring specimens have only been machined out from base X42, X52 and X60 (OD 6"). It has been not possible to produce C-rings specimens from the X70 16" OD pipe. The thickness of the C-ring specimens is determined by the wall thickness of the as-received tube. The design, machining and loading process for C-ring specimens has been carried out according to ISO 7539-5 [2] and ASTM G38 [3] standards.

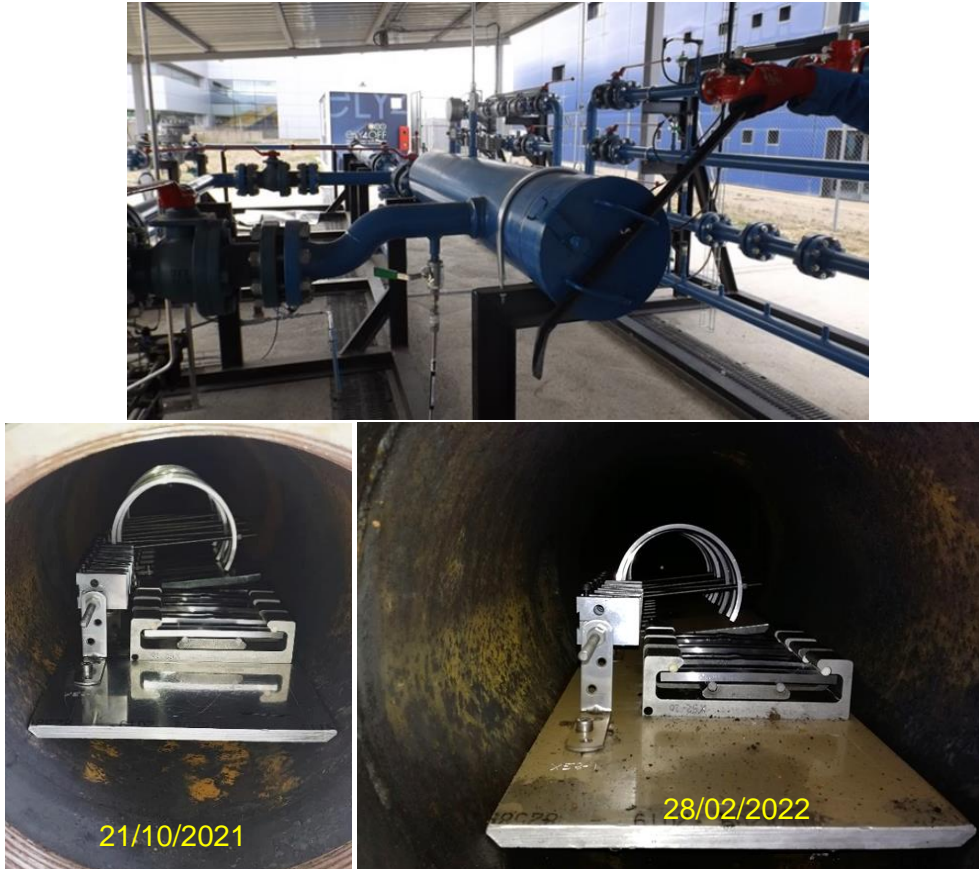
Test specimens were located inside the pig trap in the loop experimental platform at FHA and exposed from 22/10/2021 to 28/02/2023 (approximately 3070 hours) to a gas atmosphere composed of 80%CH<sub>4</sub>+20%H<sub>2</sub>. The initial gas pressure was established in 80 bar and dynamic flow conditions were applied. After the compressor failure, (10 days after the start of the campaign) the pressure in the loop dropped to 60 bar. This pressure was maintained for 1 month (from 5/11/2021 to 7/12/2021), when it was raised again to 80 bar. From this moment on, the platform was operated in a static mode. At the conclusion of the test, the dynamic section of the loop was depressurized and purged with nitrogen and the pig trap was open. Figure 5 shows the aspect of the racks with the steel specimens inside the pig trap. At the time of opening, no corrosion was observed on the steel samples. Once the outside air entrances in the pig trap, and due to the existing humidity -probably due to the hydrostatic test-, a slight corrosion is produced in the steel specimens.

**Figure 5. Test specimens inside the pig trap in the loop experimental platform at FHA at the beginning of the test, and once concluded**

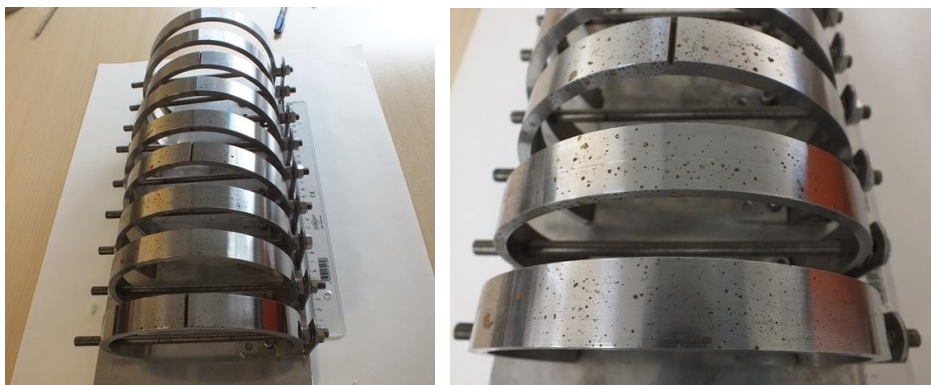
Figure 6 shows the appearance of the tested C-ring specimens. Shallow red spots of corrosion were observed, attributed to the entrance of air inside the pig trap, at the conclusion of the test. No cracks were detected after optical inspection with a LEICA S9i stereo microscope. Metallographic sectioning confirms the absence of cracks both in base and C-ring notch samples (Figure 7).

**Figure 6. Detail of tested C-ring specimens**

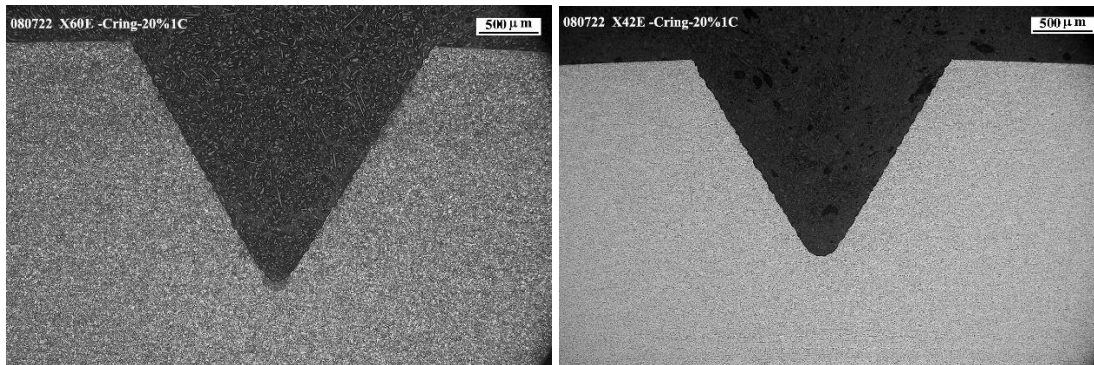
Figure 7. Optical micrographs of notched C-ring sections from steel grades X70 (left) and X42 (right)

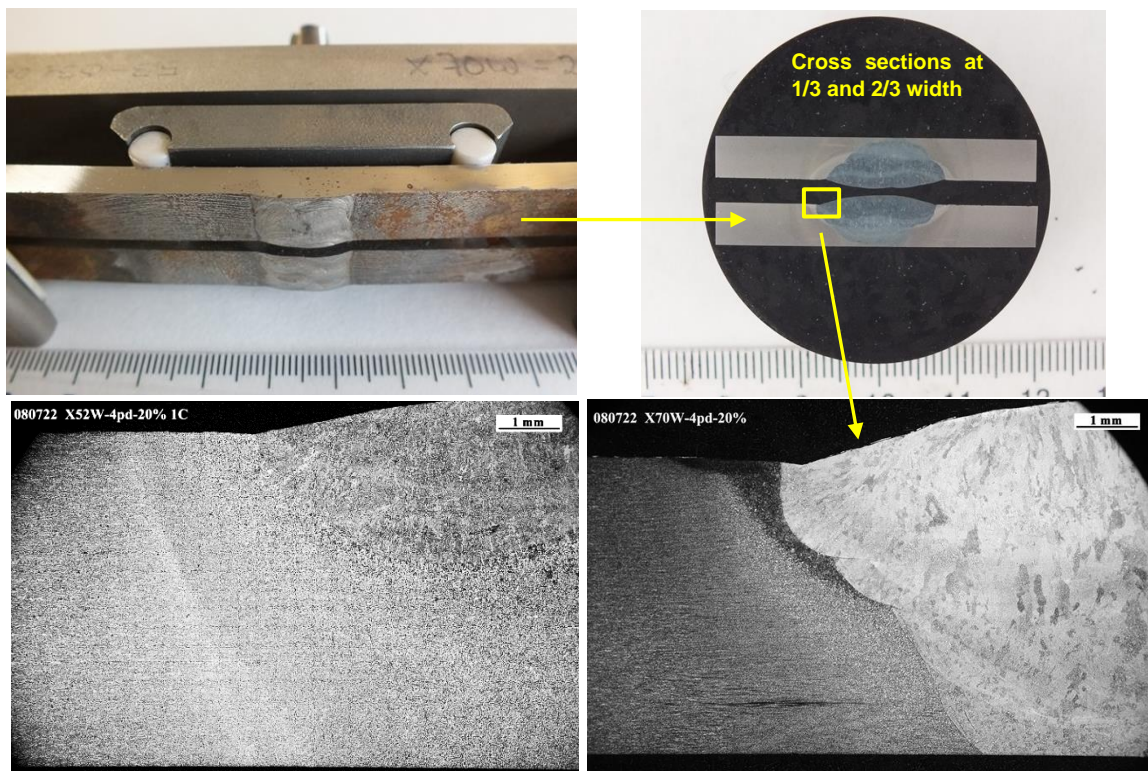
Figure 8 shows the appearance upon reception in TECNALIA of welded X70 steel 4pb specimens supported in the loading jig. No cracks were detected during the inspection with a stereo microscope. In 4pb specimens and if no cracks are detected, ASTM G39 suggests carrying out longitudinal sectioning at two locations, typically at 1/3 and 2/3 of width, followed by metallographic preparation and examination performed by optical and scanning electron microscopy (SEM). Metallographic sectioning confirms the absence of cracks in the base, heat affected zones (HAZ) and weld metal areas.

Figure 8. (Up-left) detail of 4pb X70 welded steel specimens; (up-right) metallographic probe of welded sections; (down) optical micrographs of welded joints from steel grades X52 (left) and X70 (right)

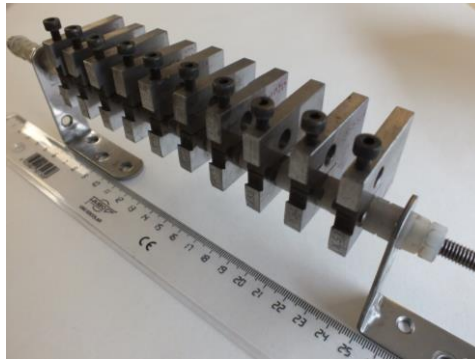
Figure 9 shows the appearance of the rack with the tested CT-WOL specimens. The CT specimens were unloaded (removing the bolt) and then heat tinted (30 min at 300 °C) and broken in order to evaluate if the initial fatigue pre-crack (generated in air before exposing the specimen to the hydrogen blend) did or did not grow. The fracture surface was examined by SEM microscopy. Measurements of the crack front extent were carried out in three positions. No hydrogen crack growth was measured for any CT-WOL specimen (crack propagation <0.25mm). Fracture surface examination reveal the same fracture mode in the fatigue pre-crack and in the crack front (Figure 10). Results for the CT-WOL specimens testing are summarized in Table 6.

Figure 9. Detail of rack with tested CT bolt loaded specimens

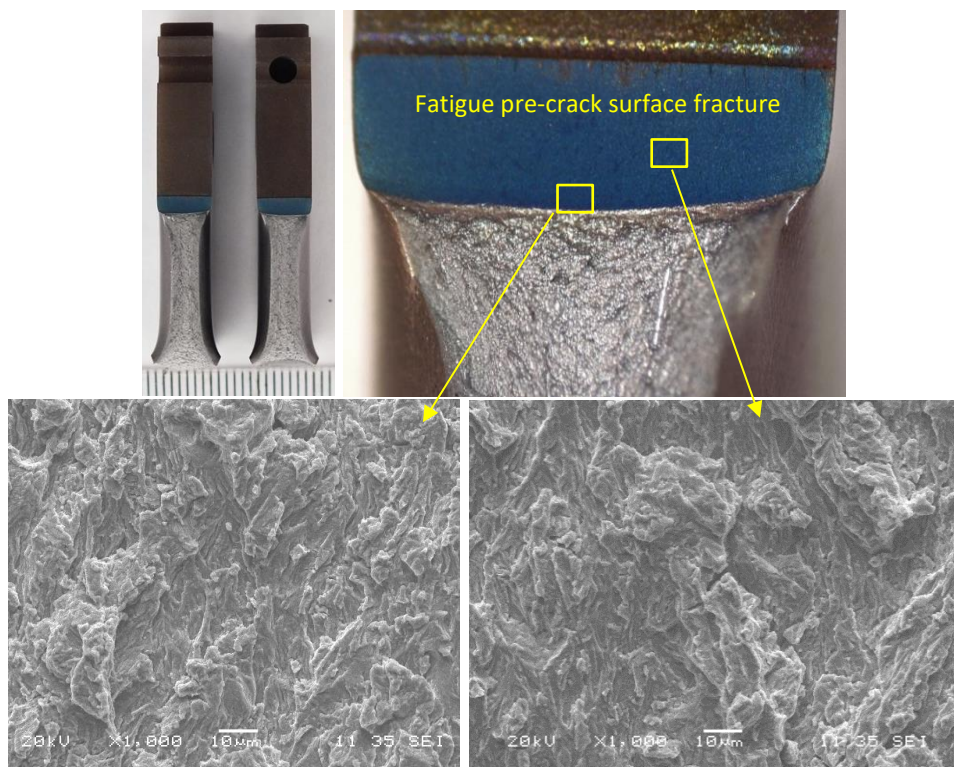
Figure 10. (Up left) two heat tinted fracture surfaces in a X70 CT-WOL tested specimen; (up right) detail of the tinted fatigue precrack; SEM micrographs of the fracture surface in the fatigue pre-crack and in the crack front

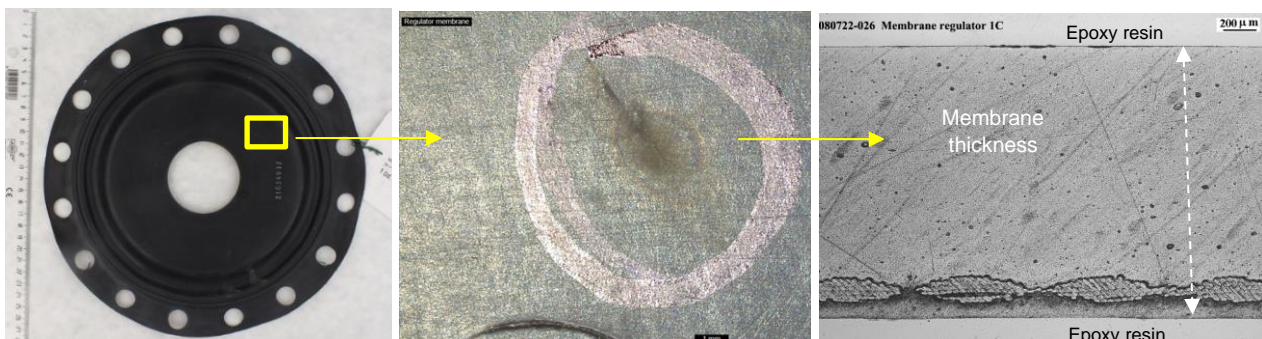
Figure 11. Parts of the pressure regulator: membrane: general appearance (left), detail of area with unknown damaged area (center) and cross section materialographic probe (right) showing a very superficial damage

A visual inspection of the items under study was carried out by TECNALIA, with the aid of a stereo microscope with a camera, to detect cracking or other type of hydrogen damage (blistering, for example). There were observed “damaged” areas, principally due to linear or scratch abrasion in certain components, but apart from this, no clear signs of hydrogen damage were observed on the different parts inspected. Only in the case of the membrane regulator it cannot be excluded the possibility of blistering due to hydrogen trapped inside polymer cavities (see Figure 11). Once the component is removed from hydrogen exposure, the blisters can gradually disappear after few days, so it is difficult to make a clear statement.

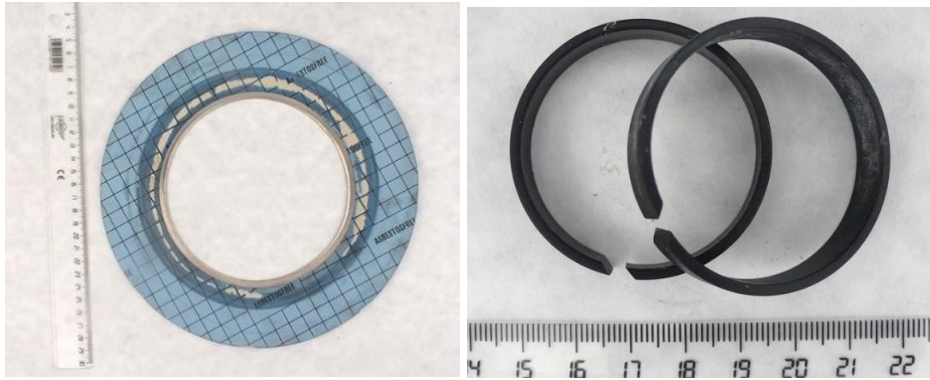
Figure 12. Parts of the regulator: gasket (left) and guide rings (right)

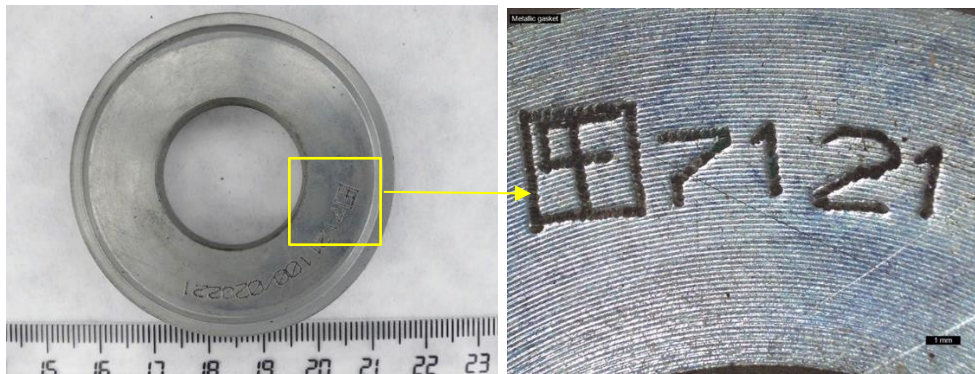
Figure 13. Parts of the regulator: metallic gasket

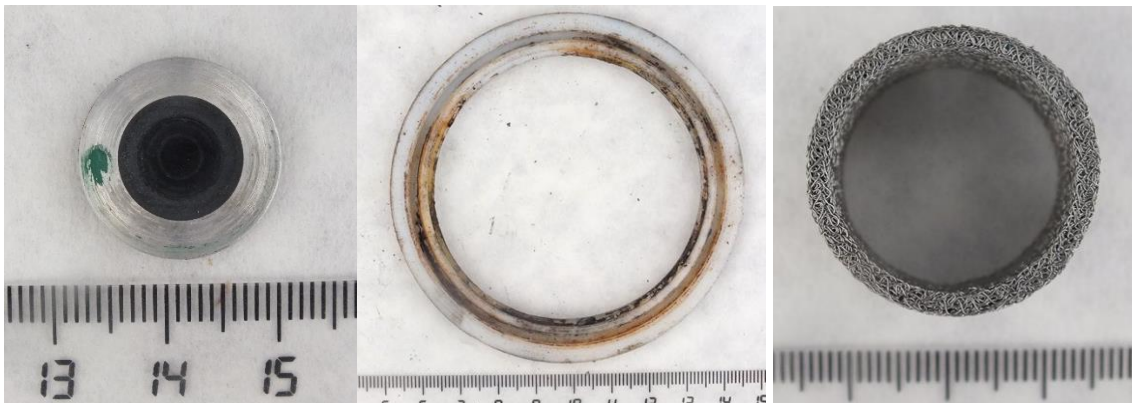
Figure 14. Prepilot: O-ring (left), filter cartridge (center) and pad (right)

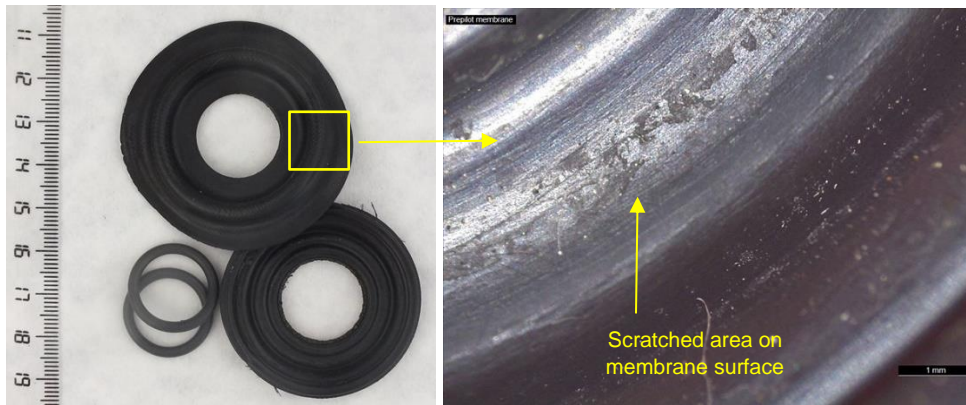
Figure 15. Pilot: membranes and guided rings (right) and detail of membrane

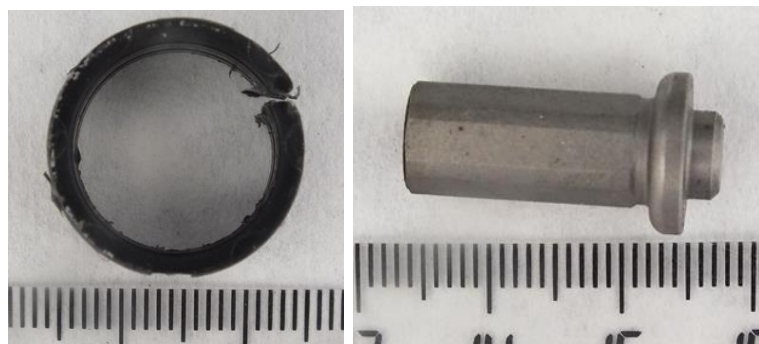
Figure 16. Pilot guide ring (left) and pilot metallic obturator

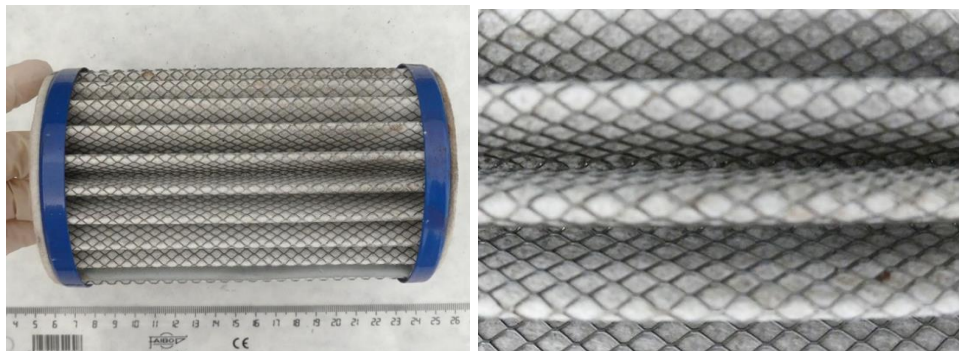
Figure 17. Filter cartridge

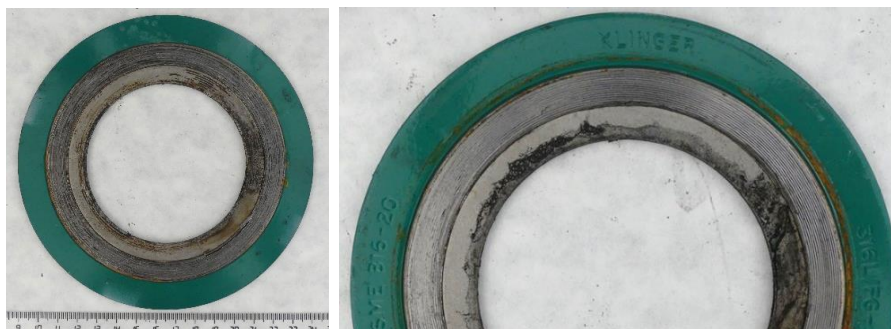
Figure 18. Spirometallic gaskets

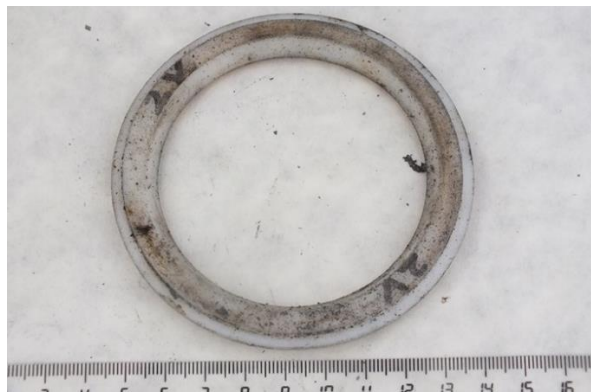
Figure 19. Butterfly valve seal

In general, the seals of both butterfly and ball valves made of Teflon, do not show any significant damage, except that which may have been generated in the process of disassembling of the valve. The seal bodies made of what appears to be Graphoil, are shown in many cases broken or fragmented, most probably due to the process of dismantling of the valve, as it is a very soft and flexible material. Figures 20 to 23 show the general appearance of some of the examined items.

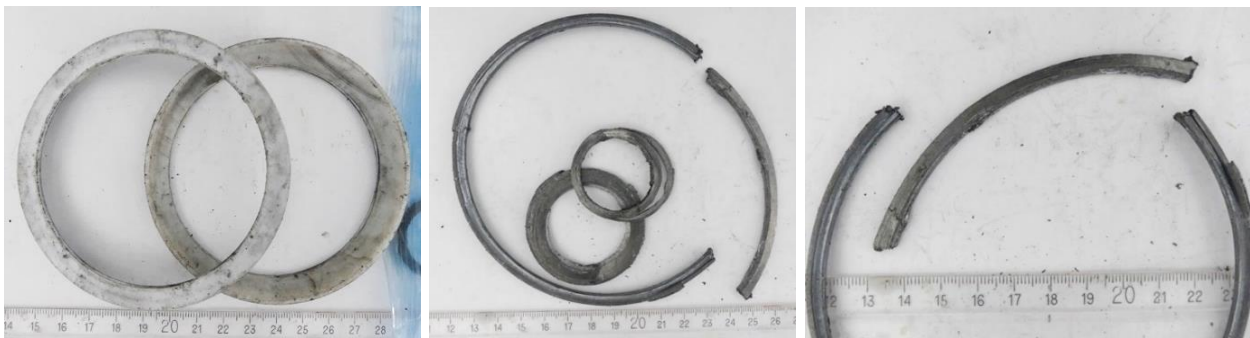
Figure 20. Flanged ball valve C-V-17. Detail of teflon seals (left) and graphoil body seals (center and right)

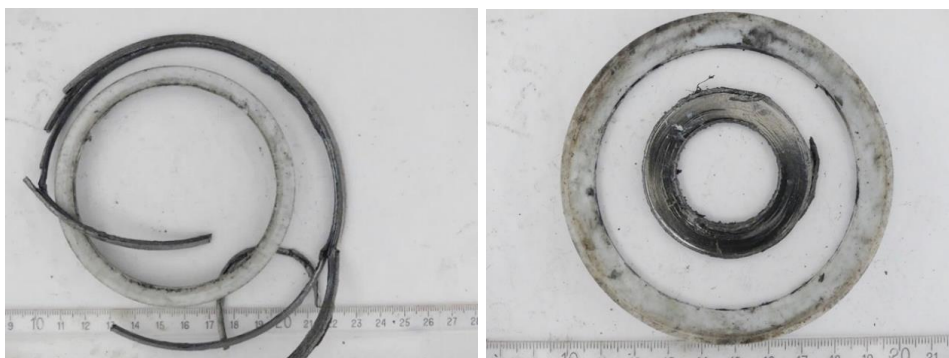
Figure 21. Detail of teflon and graphoil seals in flanged ball valve C-V-15 (left) and C-V-16 (right)

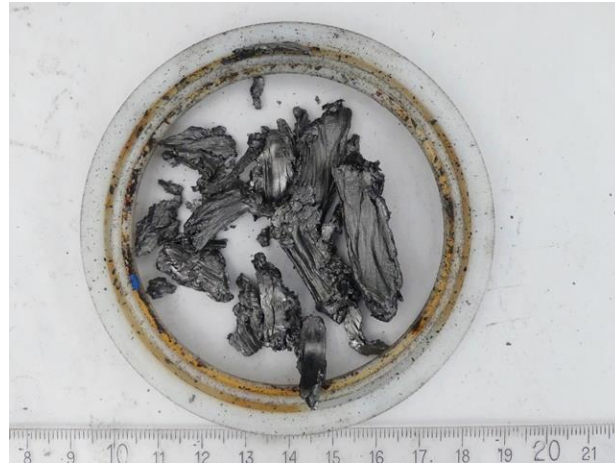
Figure 22. Detail of teflon and graphoil seals in DIDTEK butterfly valve seal

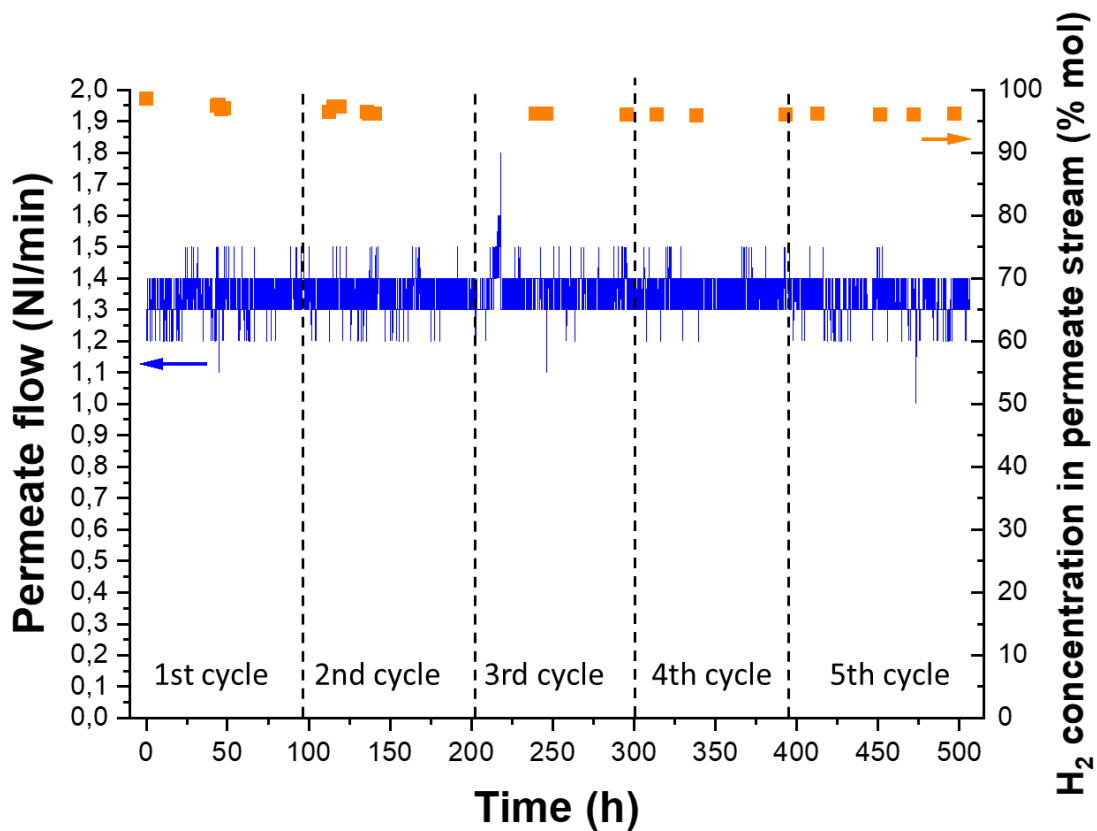
Figure 23. Gas separation performance of the prototype with Membrane #1. Blue line stands for the total permeate flow and orange scatter stands for the  $H_2$  purity in the permeate stream.

The separation of the 20/80 (%mol)  $H_2/CH_4$  blend was performed with a gas separation prototype that used Pd-based membranes. The gas separation performance of the prototype with Membrane #1 for the 500h operation is shown in Figure 23.
