Hydrogen in Gas Grids

A systematic validation approach at various admixture levels into high-pressure grids

D4.3

Update on test results

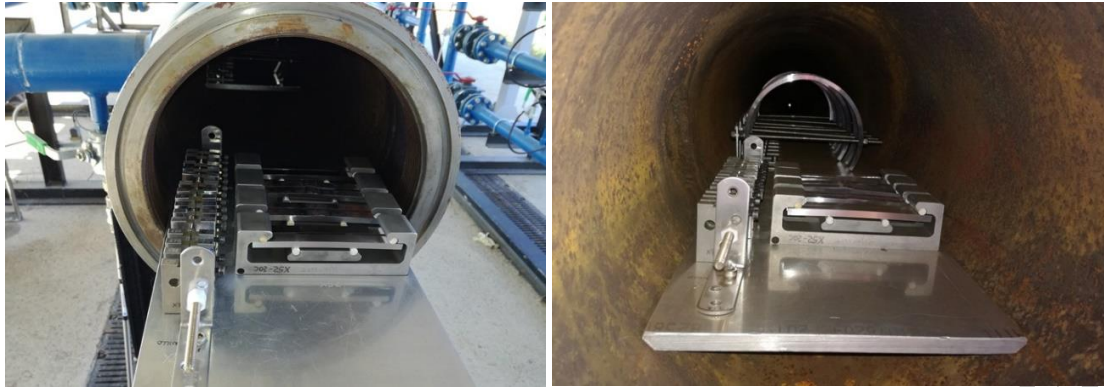
The constant displacement steel specimens were located inside the pig trap in the loop experimental platform at FHA and exposed to the gas atmospheres. At the conclusion of the test, the dynamic section of the loop was depressurized and purged with nitrogen and the pig trap was open. Figure 15 shows the aspect of the racks with the steel specimens inside the pig trap. Experimental conditions for the experimental campaigns are summarized in Table 6.

Figure 15. Test specimens inside the pig trap in the loop experimental platform at FHA at the beginning of the 2nd experimental campaign (M30) (left) and once concluded (M33) (right)

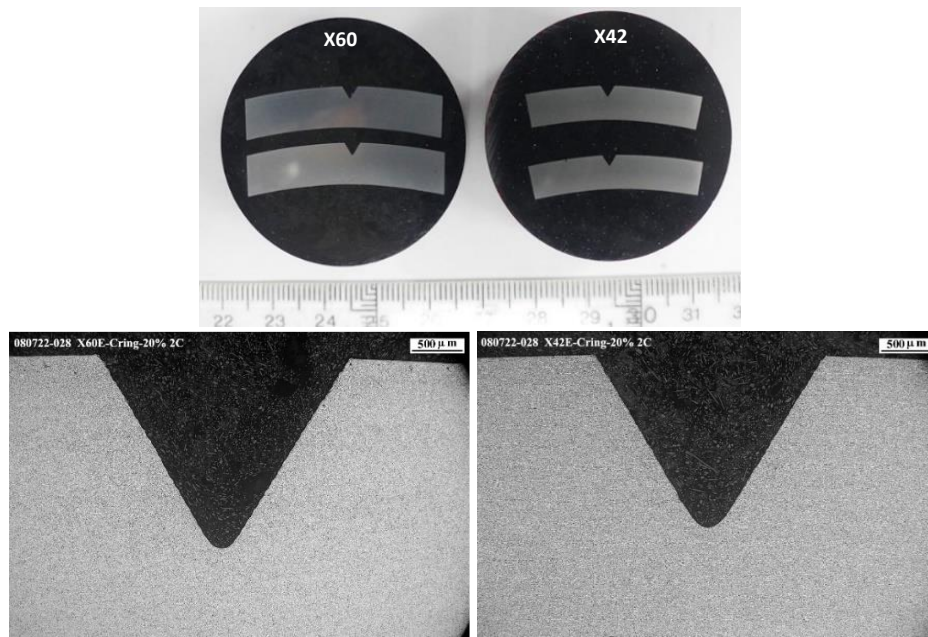
Figure 16 shows the appearance of the tested C-ring specimens after the 3rd experimental campaign. No cracks were detected after optical inspection with a LEICA S9i stereo microscope. Metallographic sectioning confirmed the absence of cracks both in base and C-ring notch samples tested in the 2nd and 3rd campaign, as shown in the optical micrographs in Figure 17, corresponding to specimens tested in the 2nd campaign. Table 7 summarizes the results obtained for the C-ring specimens in the three experimental campaigns carried out until now in the experimental platform.

Figure 17. Resin embedded notched C-ring cross sections (up) and optical micrographs from steel grades X60 (down-left) and X42 (down-right) (2nd campaign)

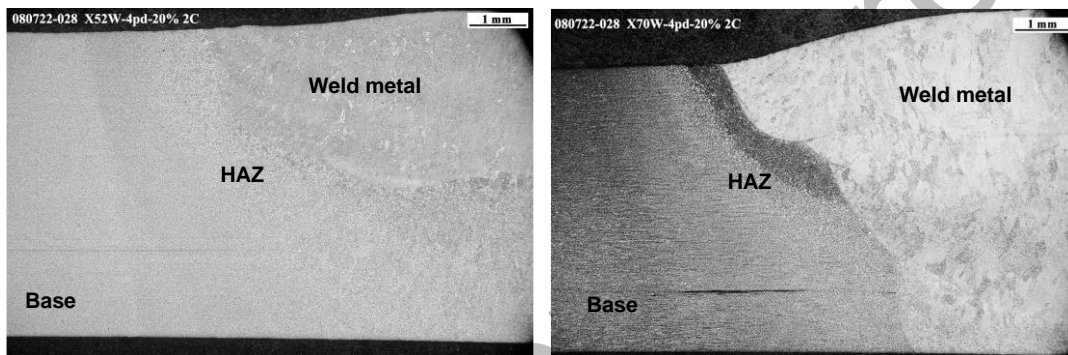
Figure 18 shows the appearance of welded X70 steel 4pb specimens supported in the loading jig, tested during the 3rd experimental campaign. No cracks were detected during the inspection with a stereo microscope. Metallographic sectioning confirmed the absence of cracks in the base, heat affected zone (HAZ) and weld metal areas both for the specimens tested in the 2nd campaign and for those tested in the 3rd campaign, Figure 20 and Figure 21. Table 8 summarizes the results obtained for the 4pb specimens in the three experimental campaigns carried out till now.

Figure 19. Optical micrographs of metallographic sections of X52 (left) and X70 (right) welded steel specimens (2nd campaign)

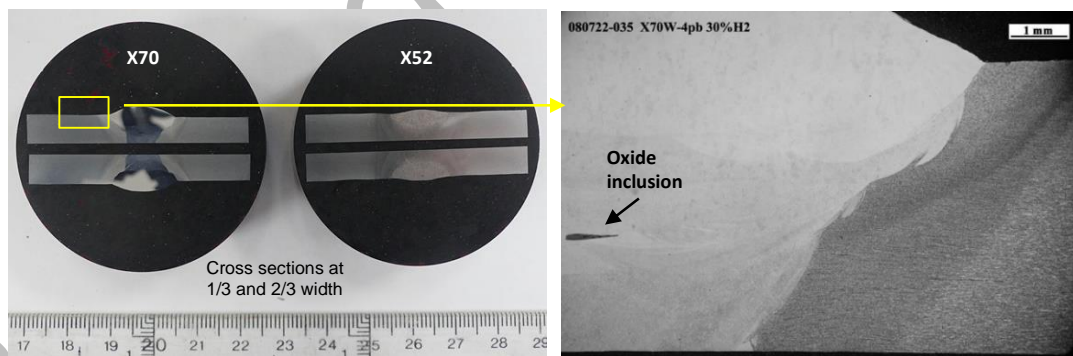
Figure 20. Resin embedded cross sections of 4pb X52 and X70 welded steel specimens (left) and optical micrograph of metallographic section of X70 welded joint (right) (3rd campaign)

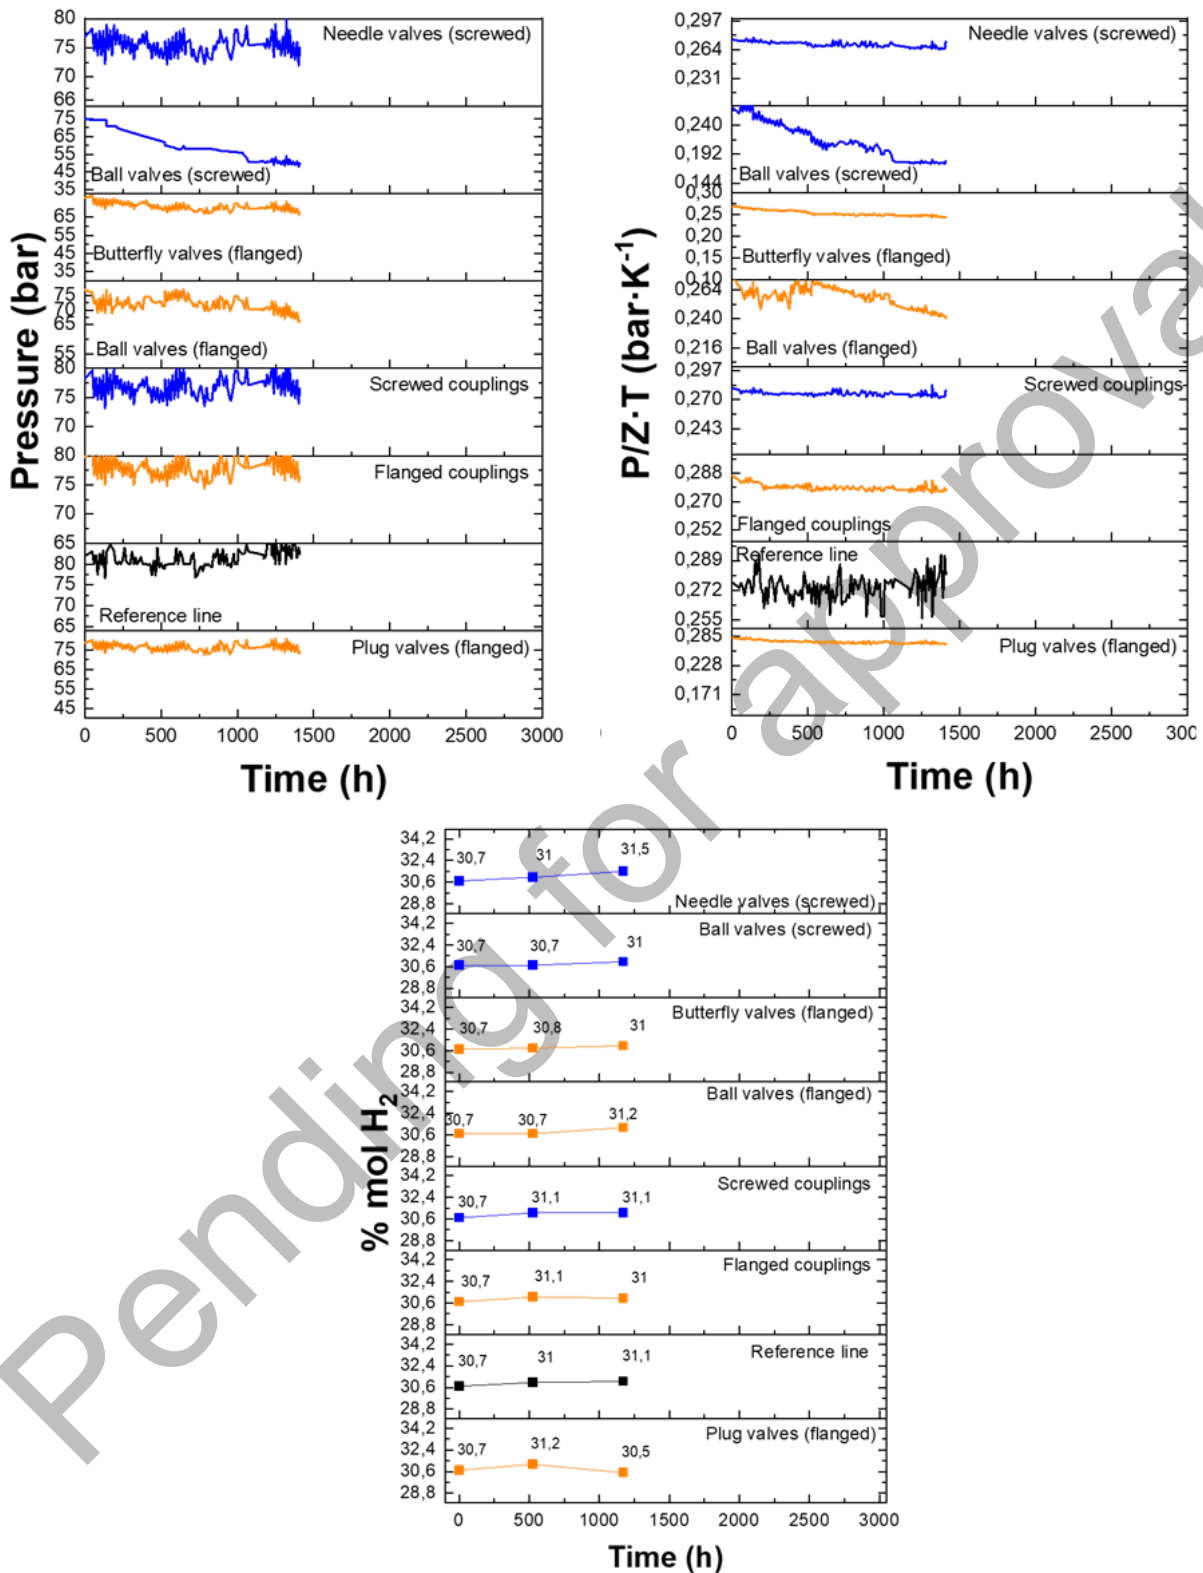
The tightness of the valves considered in Table 2 is being tested according to the methodology explained in section 3.at 80 bar with the 30 mol% H₂ blend. The test is still ongoing, but the results obtained so far during the first 1400 h are depicted in Figure 24.The evolution of the pressure and the composition of the gas (mol% H₂) for each line of the static section during the time of the experiment is given in Figure 24 (left). P/Z·T versus time is also plotted in Figure 24 (middle) to check the evolution of this relationship during the test This quotient must remain constant in a close system as long as no gas flows out of the system. The compressibility factor has been calculated using the API Soave-Redlich Kwong equation of state for each pressure and temperature value registered by the transmitters in the platform. See D4.2 for more details about the methodology. Finally, Figure 24 (right) shows the hydrogen concentration each line during the test.

Figure 24. Evolution of the pressure (top left), the P/Z·T quotient (top right) and gas composition in %mol H₂ (down) in each line of the static section during the second experimental campaign
